## **BELT CONDITION MONITORING**

**XXX COAL MINE**

**XYZ1 CONVEYOR**

**REPORT REFERENCE: CW1000**

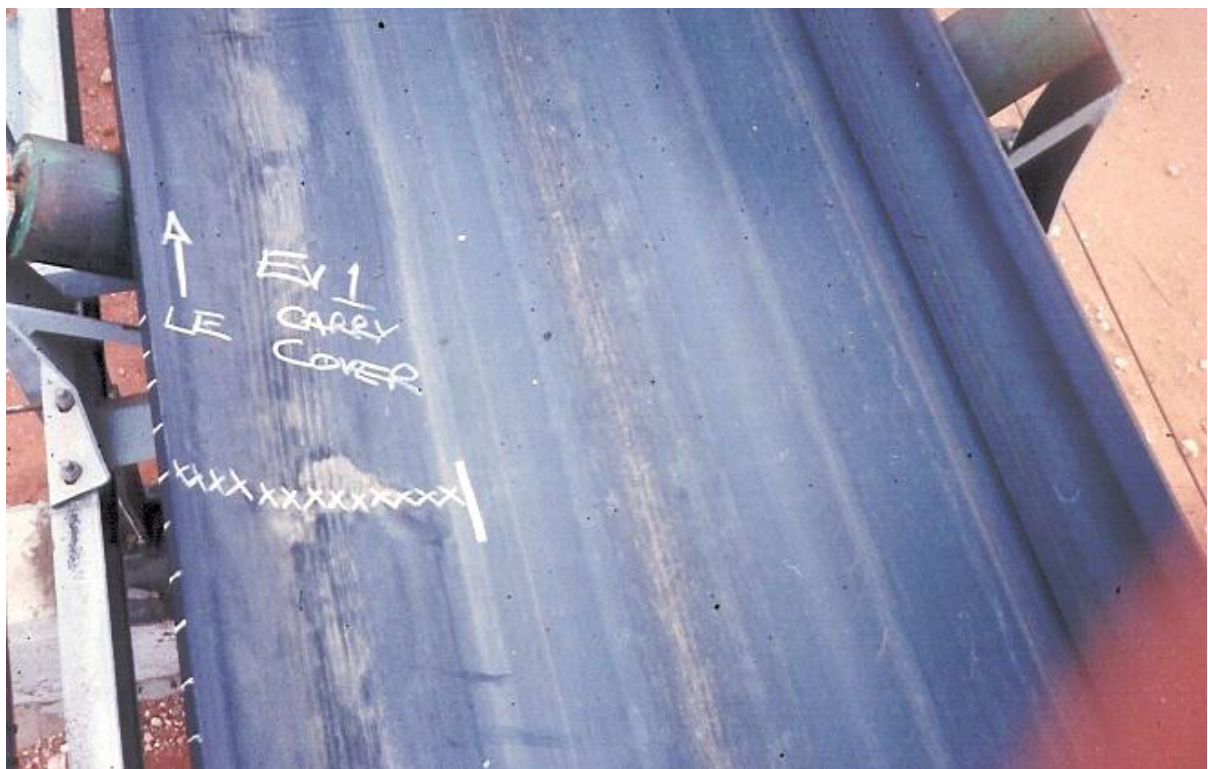
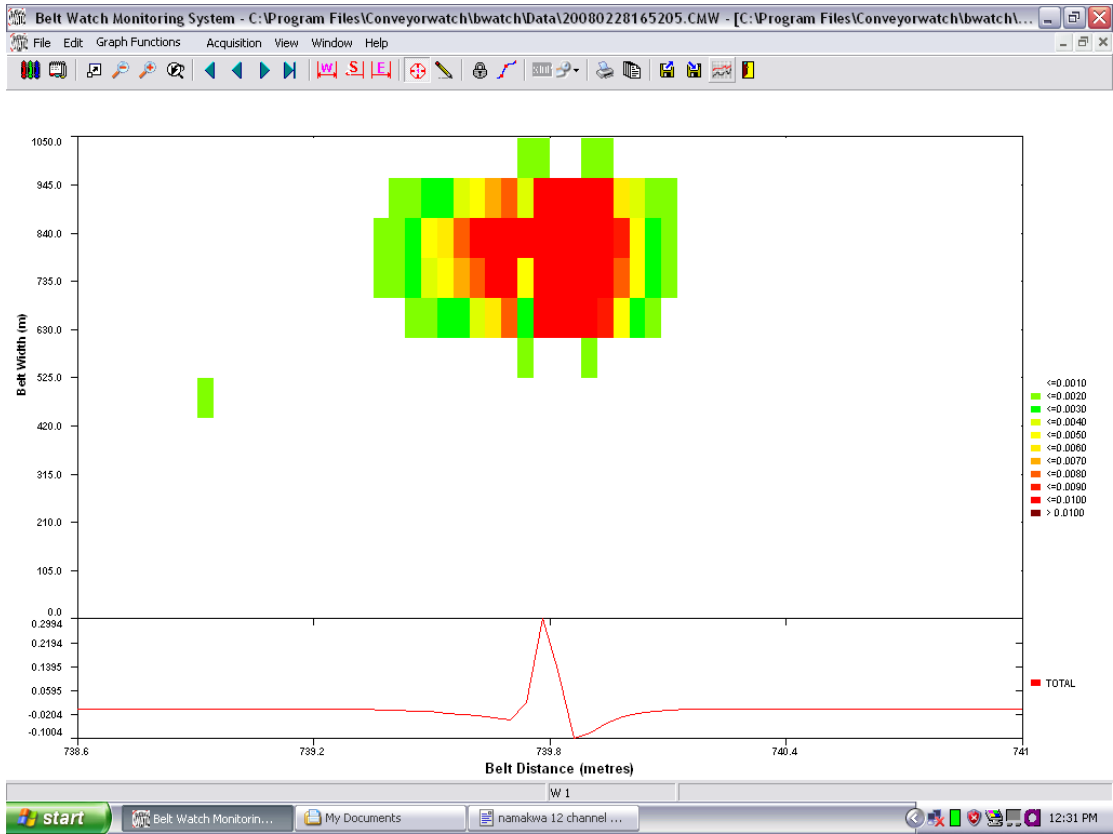
## Event 1 - Magnetic Trace

Event	Location	Findings
<b>1</b>	43 m from splice 10, (RTT26092) towards splice 11 (RTT26063)	<b>31 %</b> of the belt width has damaged cords, on the left edge. No cords are exposed. There are noticeable bumps visible on the covers.  <b>This event is recommended for removal</b>

1. Remove the belt section from splice 6, (RTT22730), through to splice 8, (RTT28308) – 471 meters in total; this section has 12 significantly large events, mostly having over 30 %f the belt width with damaged or broken cords.
2. Remove the belt section from splice 10, (RTT26092), through to splice 11, (RTT26063) – 90 meters in total; this section has 4 significantly large events, mostly having over 20 %f the belt width with damaged or broken cords.
3. Remove Event 8 – 30 % of the belt width has broken or damaged cords.
4. Inspect event 9 for damage – 13 meters from splice 22 towards splice 23. If cords are exposed, repair as necessary.
5. Rescan the belt after a further 6 to 12 months of normal operation.

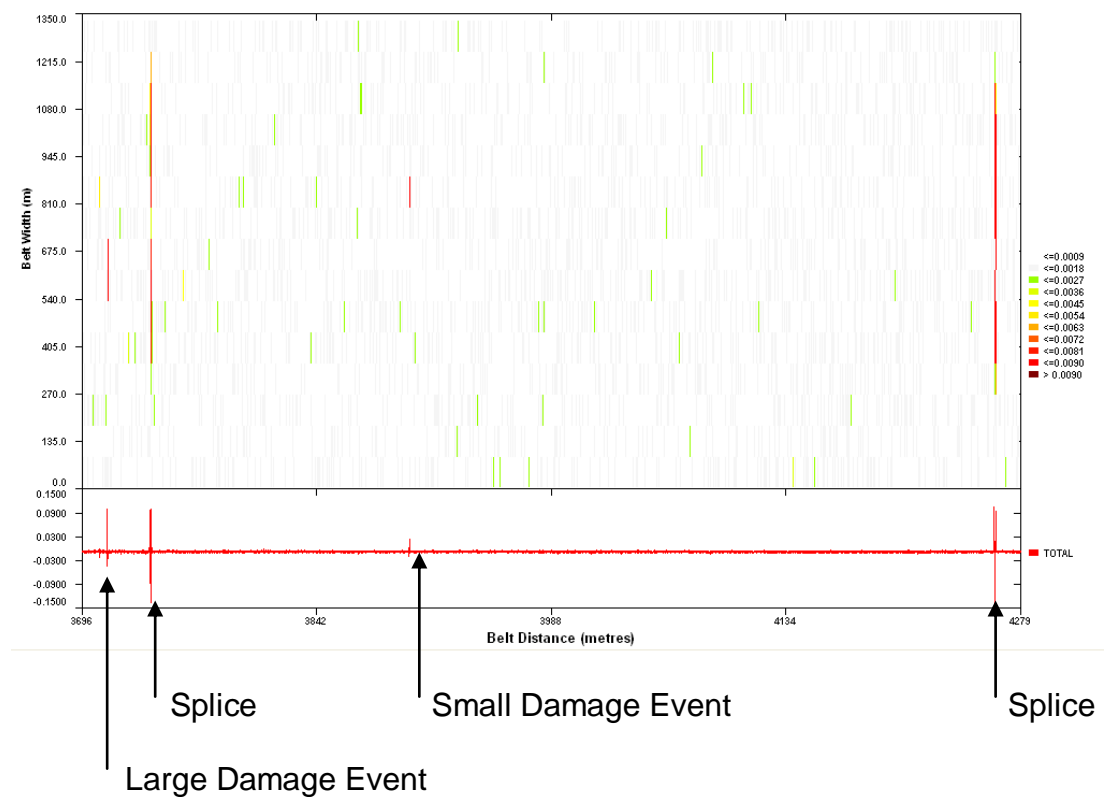
Typical trace of 600 metres of belting showing 2 splices and 2 damage events, one small and one large.

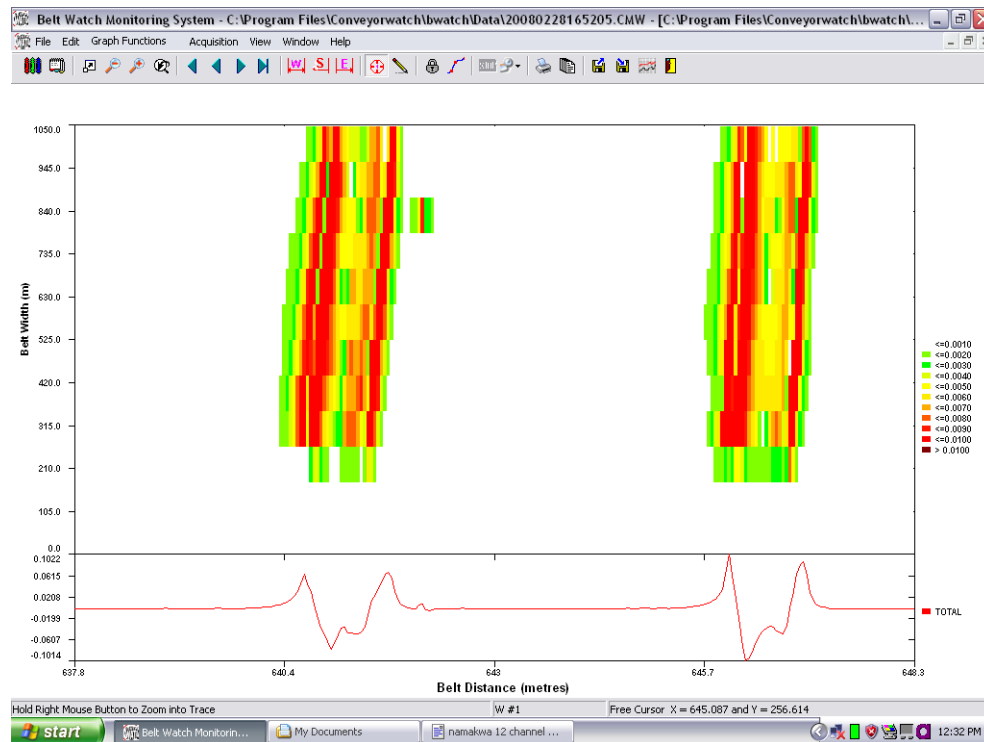
Typical example of 2 good single stage splices with some damage downstream of splice 1.
